Northwest General Aviation

Airfield Pavement

Performance Equations

**A report submitted in partial fulfillment
of the requirement for the degree of**

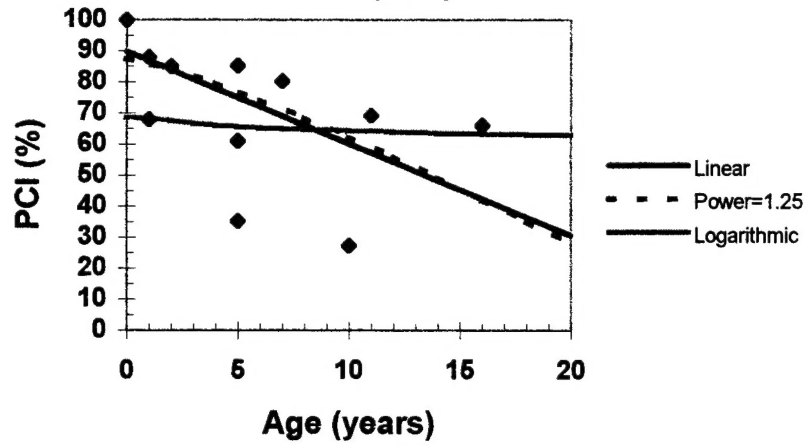
Chip Sealed Pavements (WA)
